#### 2615W-TO SUIT FORD FG FALCON SEDAN & FAIRLANE XR6, XR8, G6 ENSURE INSTRUCTIONS ARE UNDERSTOOD BEFORE INSTALLATION.

# FORD EL FALCON FORD FG FALCON/G6/G6E/G6E TURBO Part No: 100319-WL

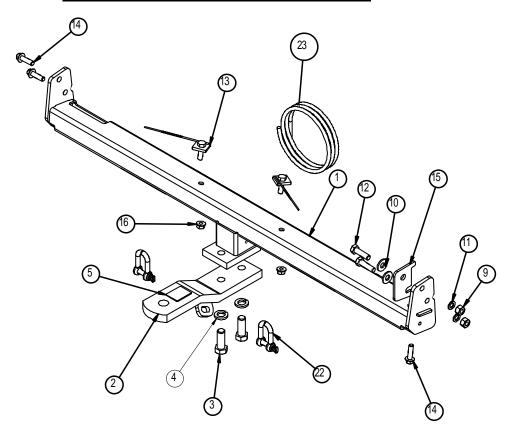
ITEM NO.	DESCRIPTION	QTY.
1	WELDED ASSEMBLY	1
2	LUG ASSEMBLY	1
3	M16 x 45 2.0P BOLT	2
4	M16 X 5 X 3.5 SPRING WASHER	2
5	H.R STICKER	1
6	ACRYLIC CP	1
7	ASSEMBLY BOLT PACK	1
8	Plastic Sheet Bag	1
9	M12-1.75 Z/P HX NUTS	2
10	WASHER M12x28.8x3mm	2
11	M12 X 4.0 X 2.5 SPRING WASHER	2
12	BOLT M12-1.75x40 GR8.8	2
13	M10 X 35 LOOSE PLATE & WIRE	2
14	BOLT TAPTITE M10x30 1.5P	3
15	PACKER PLATE	1
16	M10 WHIZ NUT	2
17	BRAND BAG	1
18	PLASTIC SHEET BAG	1
19	FITTING INSTRUCTIONS	1
20	Warranty Card	1
21	LRL	1
22	d' shackle	2
23	WIRING LOOM	1

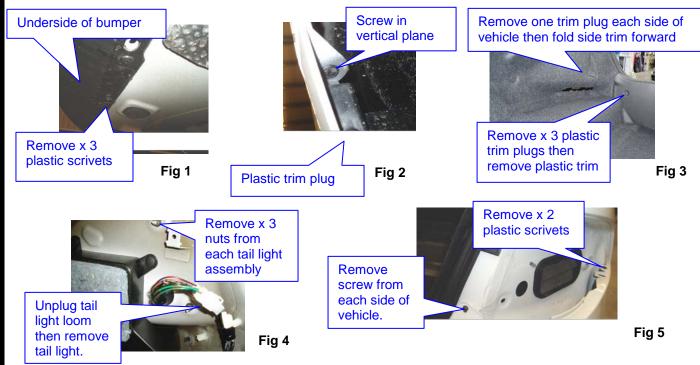
- a. Remove 3 x plastic scrivets from underside of bumper bar skin see fig 1.
- b. Remove 3 x plastic trim plugs from each wheel arch, one screw in the vertical plane & one screw in the horizontal plane see fig 2.

- c. Remove 3x plastic trim plugs from plastic trim inside boot cavity see fig 3.
- d. Remove plastic trim then fold carpet forward rear seats may need to be folded forward.

- e. Remove 1 x plastic trim plug each side of side carpet trim then fold back to gain access to tail light assemblies.
- f. Remove 3 x nuts from each tail light assembly then unplug wiring loom see fig 4.

- g. Remove tail light assemblies ensuring that grommet is pushed through panel see fig 5.
- h. Remove 2 x screws from underneath taillight cavity see fig 5.

- i. Remove 4 x plastic scrivets from underneath taillight cavity see fig 5.
- **j.** Caution two person lift required flex bumper bar skin out at the sides then pull rear ward some force may be required to remove.

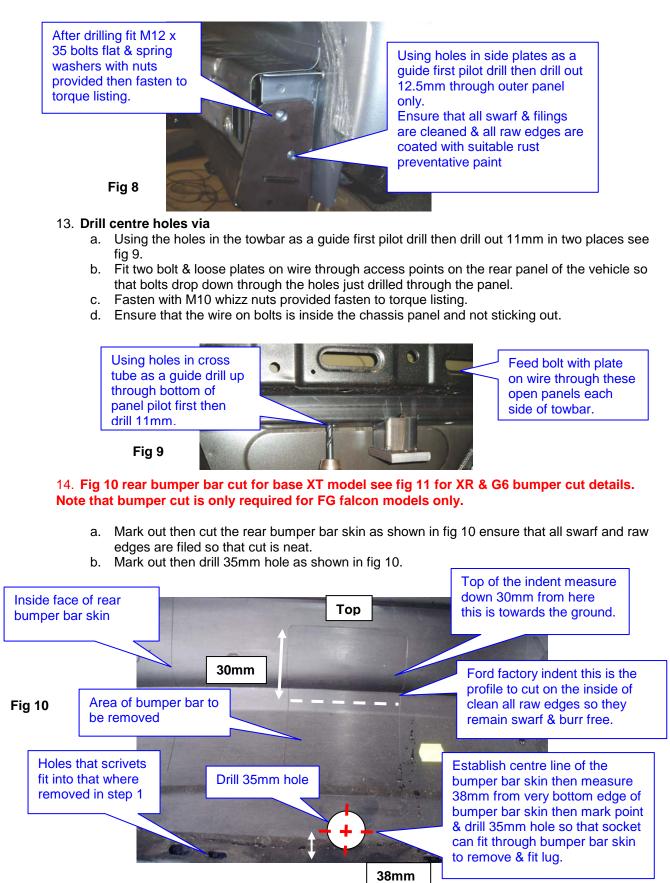
- a. Offer tow bar to the vehicle sub frame then fasten with driver side vertical mount with taptite bolt provided see fig 6.
- b. Fasten passenger side horizontal mounts with taptite bolts provided see fig 7.
- c. Using holes on driver's side plate as a guide drill pilot holes first then drill through 12.5mm see fig 8.
- d. Fit M 12 x 35 bolts flat & spring washers provided ensure that packer plate is fitted between side plate of towbar & end of chassis mount see assembly detail for correct orientation of components.

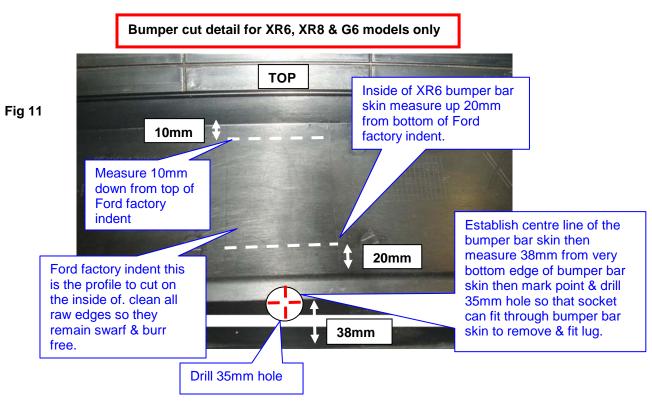
#### 15. Refit the rear bumper bar skin

- a. Refit the rear bumper bar skin in the reverse of steps 11h through to 11a
- b. Fit the towbar tongue with the two 16 x 45 bolts & spring washers provided fasten to torque listing.
- c. Fit shackles to chain connection point.
